# Cold Climate Housing Research Center

## CCHRC Research Snapshot 07-10

## CCHRC Roof Hydrology During Spring 2007 Break-up

By Colleen Rust, Daniel Reichardt, Jeff Derry and Michael Lilly

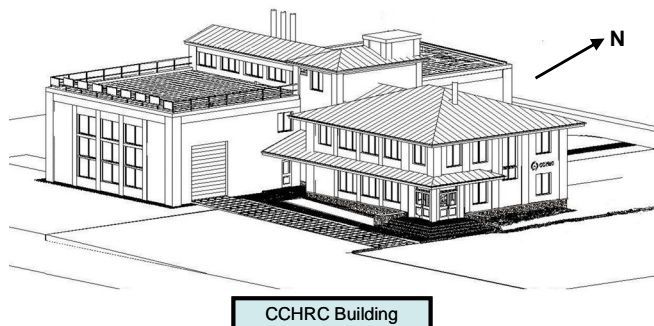
Figure 1. CCHRC Research and Test Facility (RTF). Green roofs are on west side, the main office roof is on the east side.

During the 2007 spring break-up, we monitored various snowmelt and runoff processes of the CCHRC building and surrounding grounds. The intent was to gain general knowledge of water dynamics and to look at volumes of available water from both green roofs, and the roof of the administration building (Figure 1, 2).

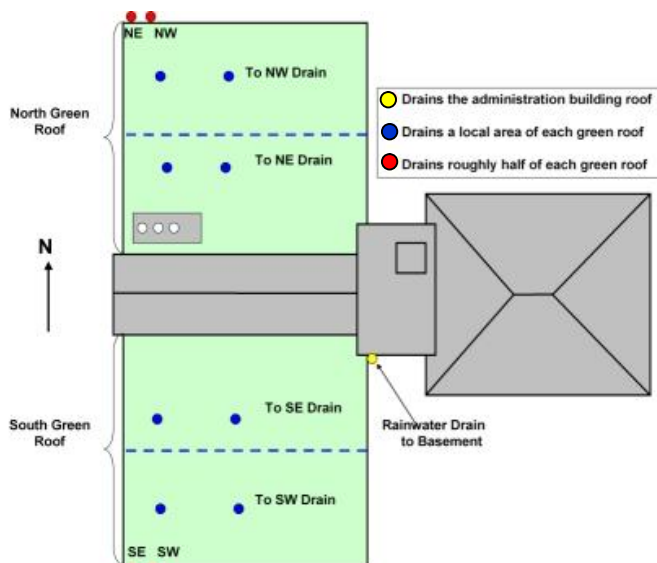
Figure 2. There are two green roof test systems, one on the North Bay, and one on the South Bay. Each of the green roofs has two drainage areas splitting the green roof areas approximately in half. The Office Roof System has gutters that catch runoff from the south and east sides and drains to holding tanks in the basement.

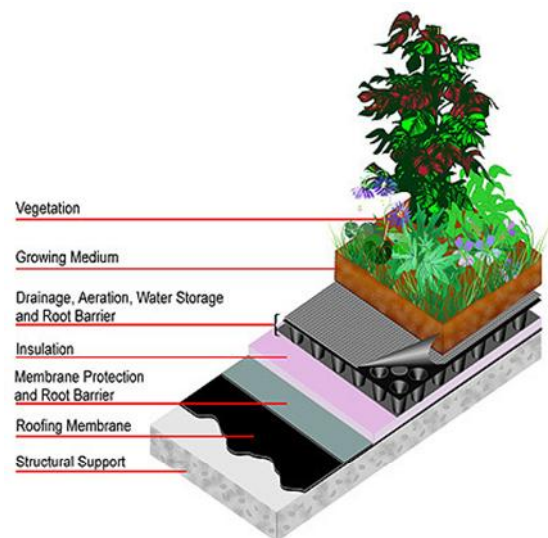
Figure 3. Typical profile through a green roof system.

Snow-pack measurements were made on each green roof (Figure 3) and the snow-water equivalent (SWE) for the end of winter was estimated. This was done by establishing snow-depth transects on each roof and measuring three snow densities at each transect.

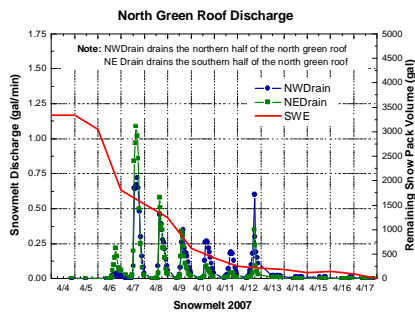
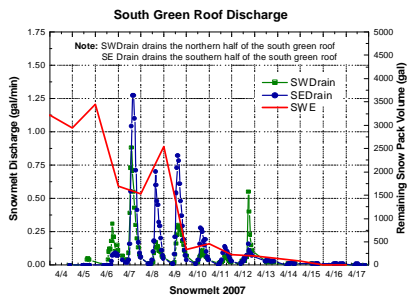
Figure 4. Snowmelt observations from the three roof areas are shown in the graphs to the left and right. The graphs on the right show the reduction in SWE on each roof and the runoff from the roof drains. The diurnal runoff trends can be seen in the individual measurements.

- ◆ Peak runoffs were ~ 1-2 gal/min.
- ◆ One-day time lag between the administration building roof and the green roofs.
- ◆ A rain event on 4/12/07 shows up as a stronger peak on the office roof versus the two green roofs.
- ◆ Preferential melting occurred around the green roof drains.

Discharge from the roof drains were also measured during snowmelt to calculate the amount of water draining from each roof (Figure 4) Runoff from each drain was measured for the two green roofs and the volumes were added together. The drain from the office shingled roof drains the southern and eastern side of the office roof. Pictures were taken to record the distribution of snow during snowmelt (Figure 5, 6).

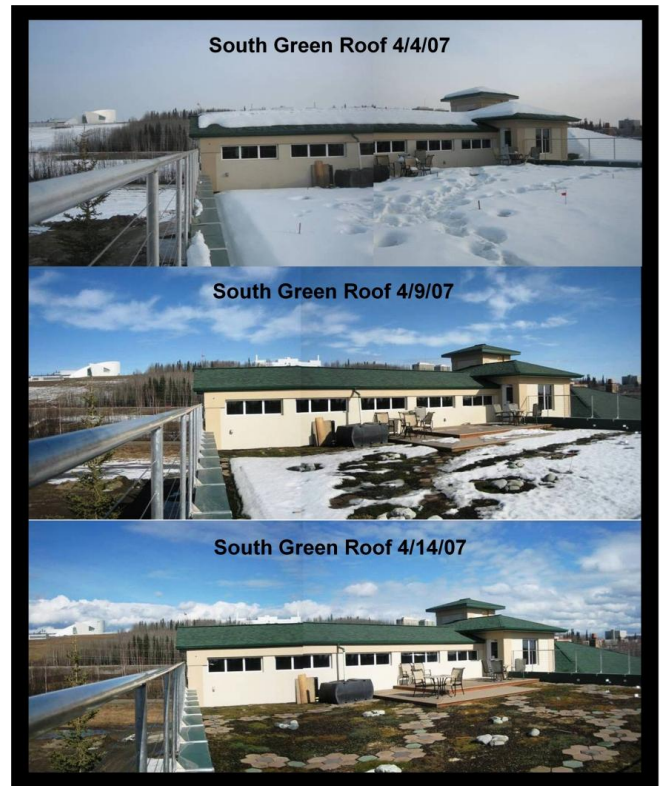
Figure 6. Snow distribution is shown for the South Bay Green Roof. This roof receives less shading. Melting around the roof edges can be seen in the middle photograph. Paths and disturbed areas in the snow also melted earlier. The mezzanine roof drain also contributed water during snowmelt.
